BIKINI SCIENTIFIC RESURVEY. VOLUME III. REPORT OF THE DIRECTOR --ETC(U)
DEC 47

Bikini Scientific Resurvey, Annex II

PILOTFISH: GENERAL DESCRIPTION OF DAMAGE

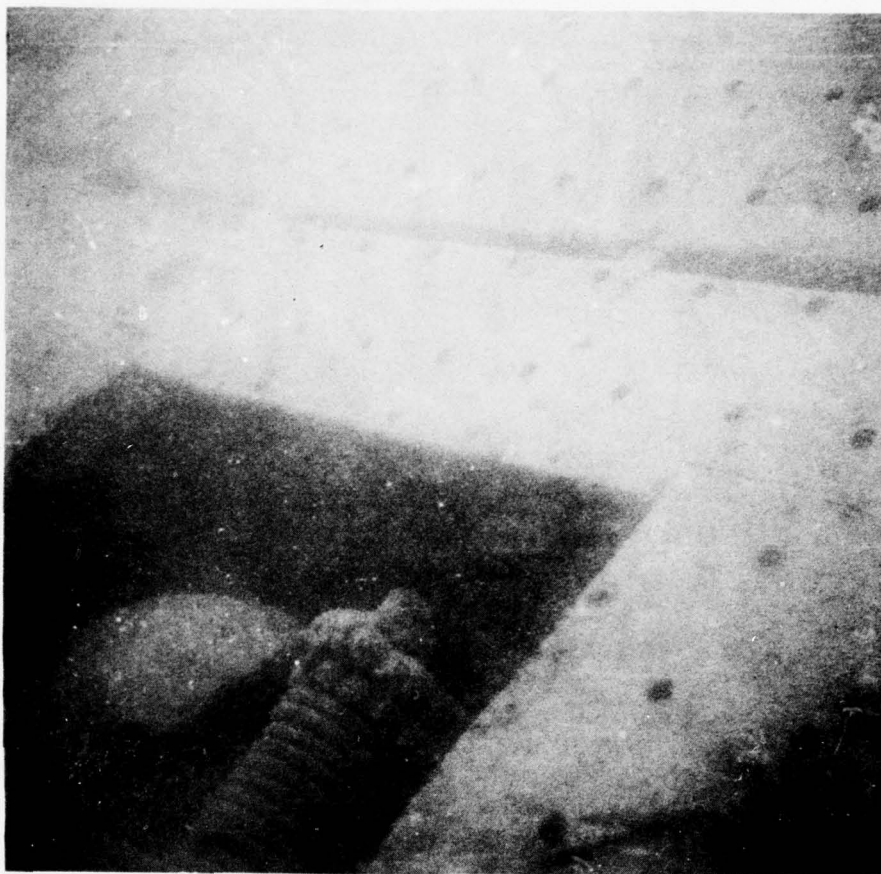
View of after engine room hatch, looking aft and port. ABCR
Photo No. 6035-2.

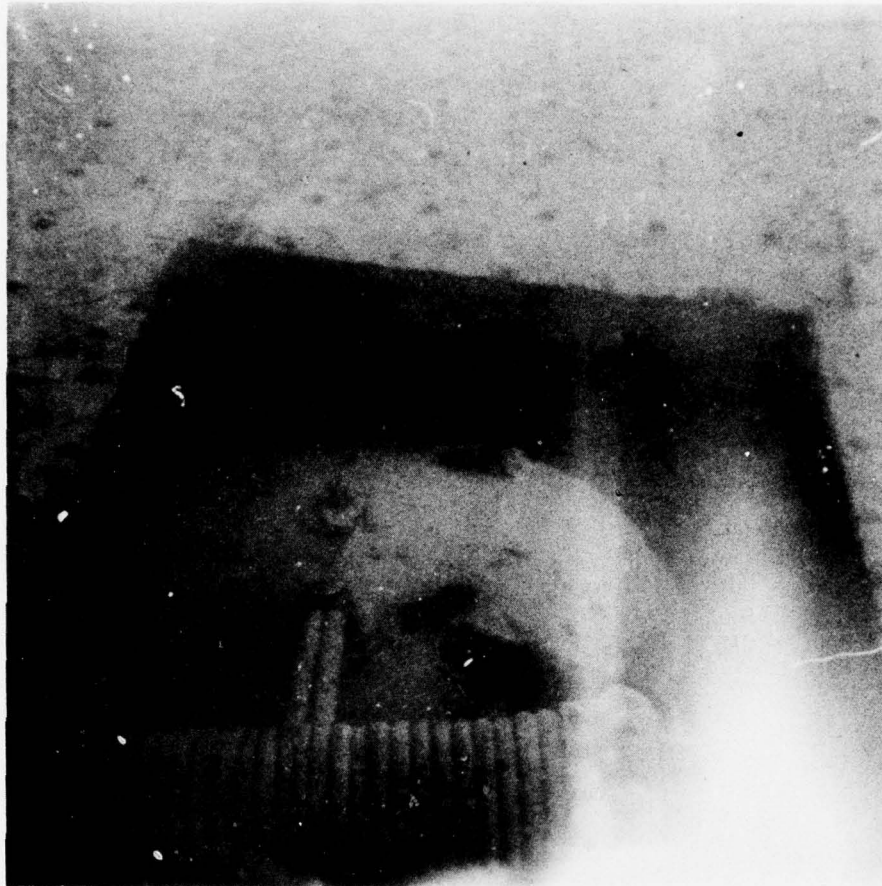
View of after engine room hatch. ABCR Photo No. 6044-3.

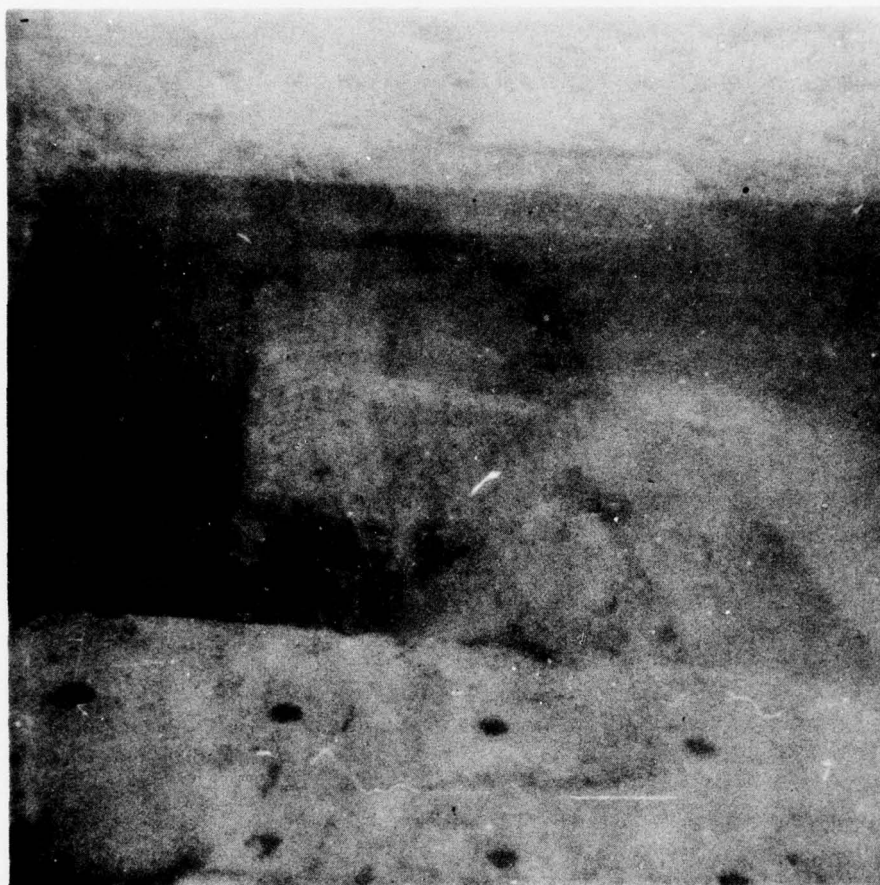
View of after engine room hatch, looking to starboard. ABCR
Photo No. 6044-4 End.

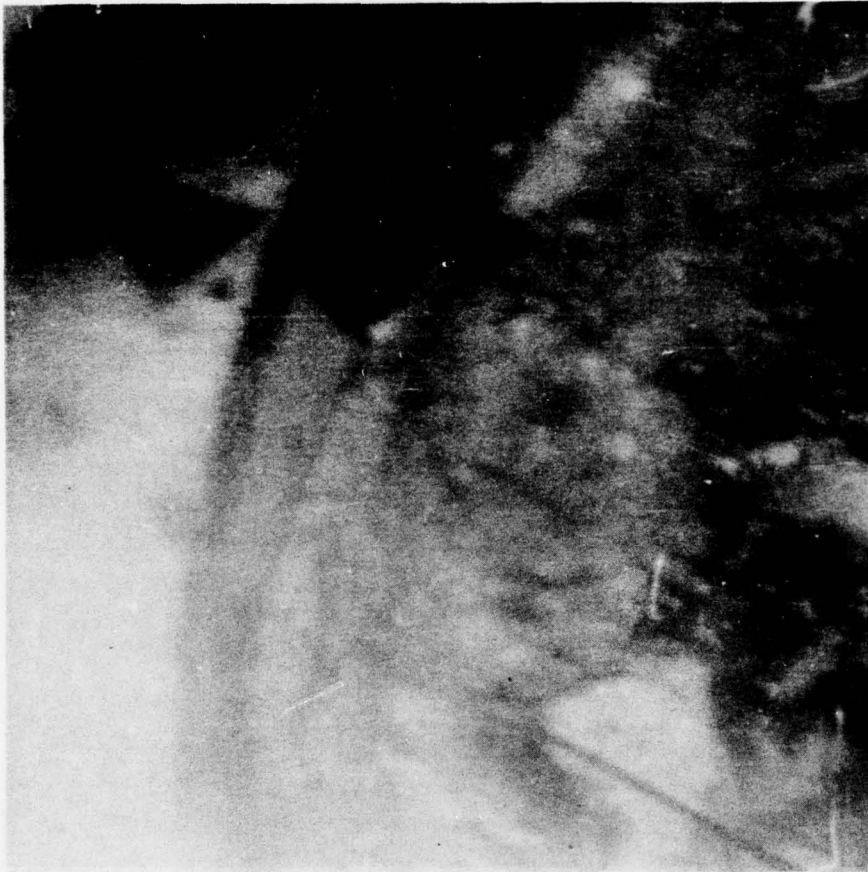
View of main induction valve looking down showing displaced top on seat. ABCR Photo No. 6046-7.

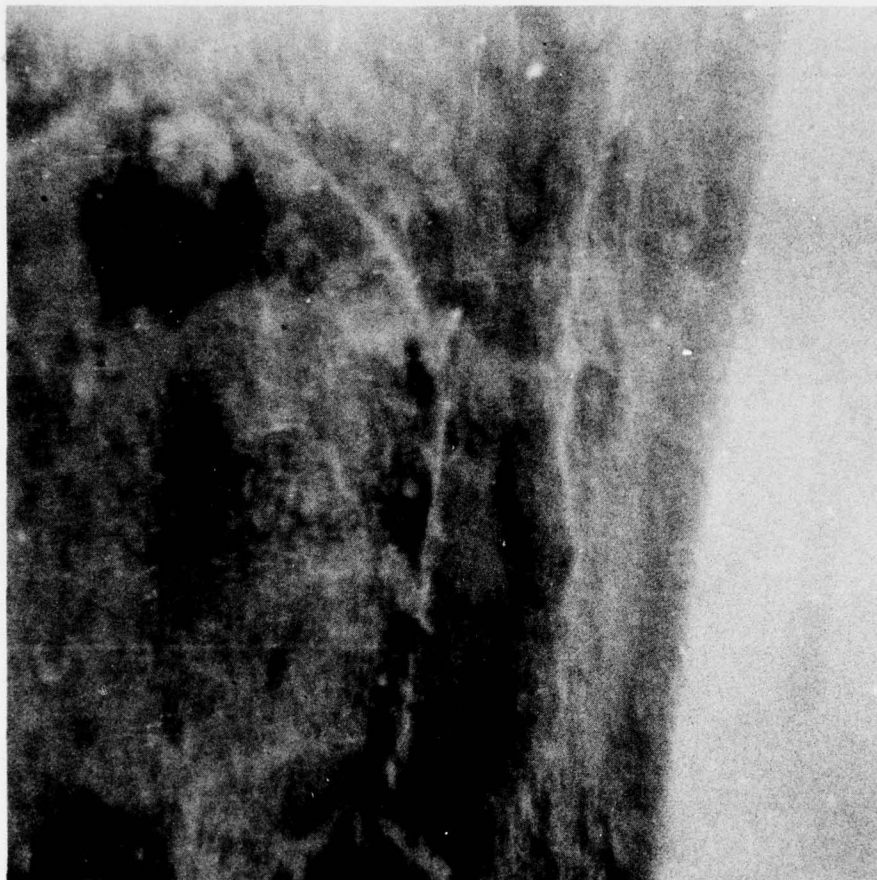
View of after periscope shear showing dented hand hole plate
on forward side. ABCR Photo No. 6048-8.

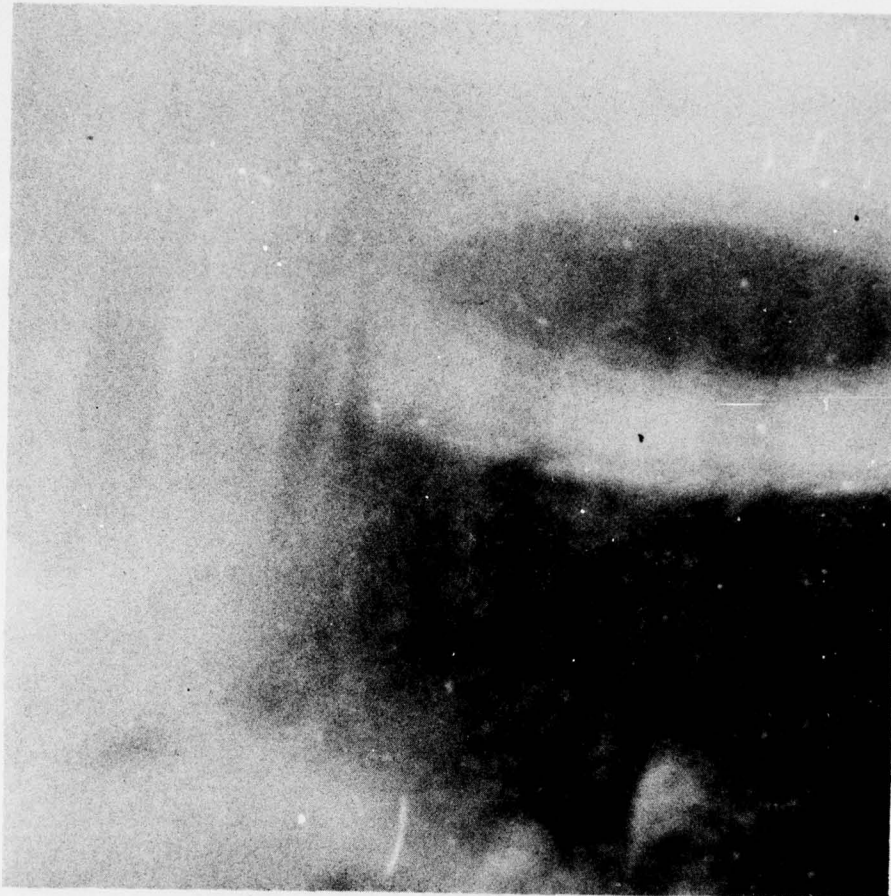
View of top of #1 periscope shear. ABCR Photo No. 6048-9.
